# From the street, to the attic

## Louis Noel Villa

Emile Zola no. 6 street, Bucharest

# What is Villa Noel?

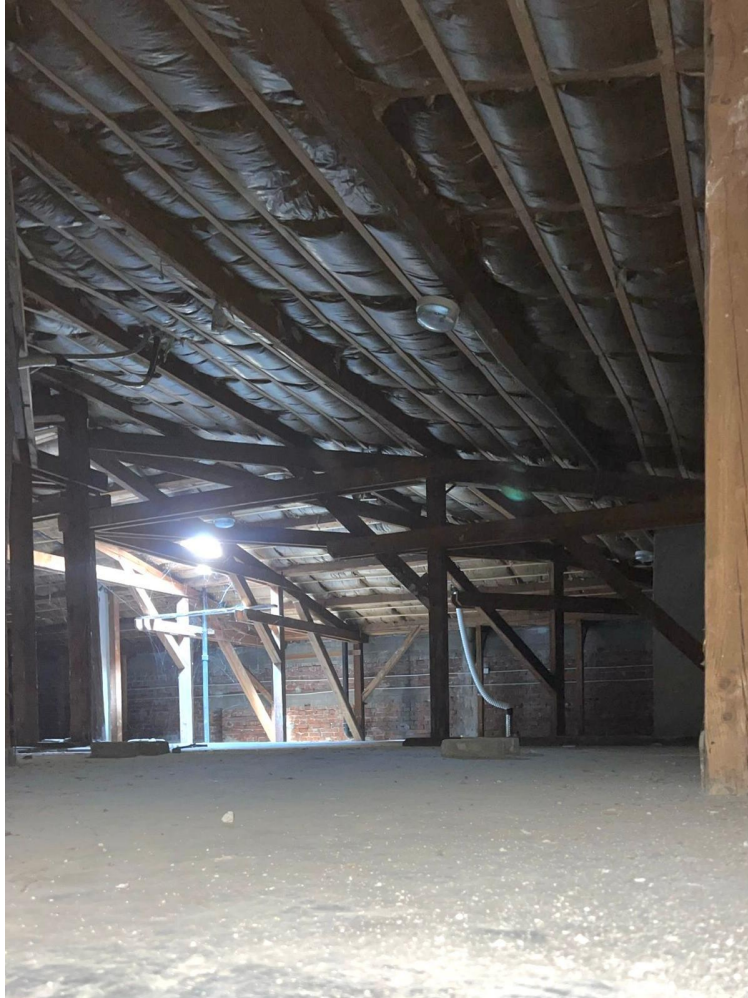
## Identified problems of the villa:

### A. Based on site visit

- **unused attic that can be restored to host activities;**
- **the reading room's size is limited and doesn't allow larger interactive events;**
- **current access to the attic is only a small ladder in a cramped room;**
- **the "staff" area in the back of the villa has a narrow corridor that barely allows 2 flows of people to circulate;**
- small cracks in the walls, perhaps posing structural issues;
- malfunctioning heating system;
- bad odor in the basement due to heaters;
- the building is mostly vacant, except for when events are hosted;
- the housing units take up a lot of space that could be used to expand the activity spaces;
- beautifully designed stone flooring is only present in a small room that is currently only used for storage.

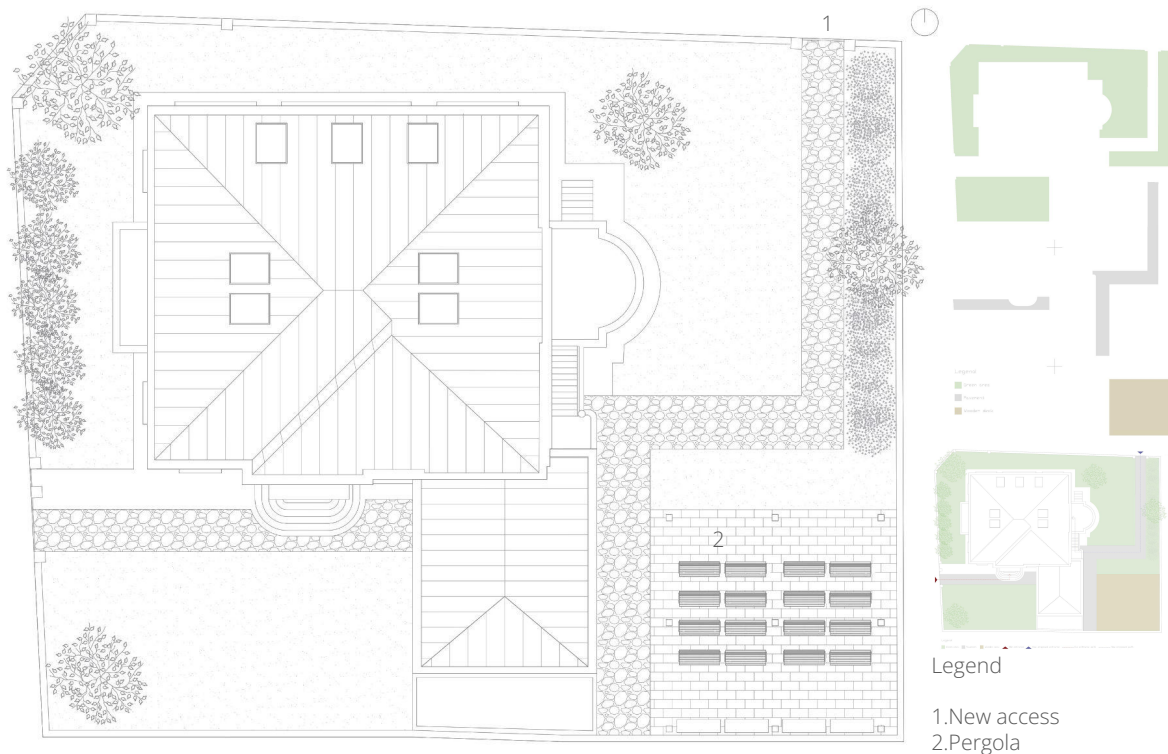
# Garden and new access

A definite start for the concept is the street: the Villa's only entrance is currently from a secondary street, the main one having no openings whatsoever. While this was beneficial in the original design to make the courtyard more private for the inhabitants, its current use urged the usage of the landscaping elements and processes to connect the existing entrance and walkway to a new circulation, open directly from the main street. A thick layer of vegetation, new pavement and a complete re-thinking for outside activities led outlined the proposal. A new gate, chosen to keep the same design language as the original fence but slightly different to mark our intervention, opens up towards the newly-paved walkway. Following the stone tiles you reach the courtyard, now sprawling with various trees, flowers and plants. The wooden structure in the back-most area of the courtyard now hosts events and conferences outdoors, the wooden deck and inter-changeable furniture adding a convenient and ergonomic character to the place.
